STORMWATER BEST MANAGEMENT PRACTICES, MOSQUITOES, AND WEST NILE VIRUS

Monte Deatrich and Warren S. Brown, P.E.
Tri-County Health Department

Field Investigation of BMPs Associated with Mosquito Breeding

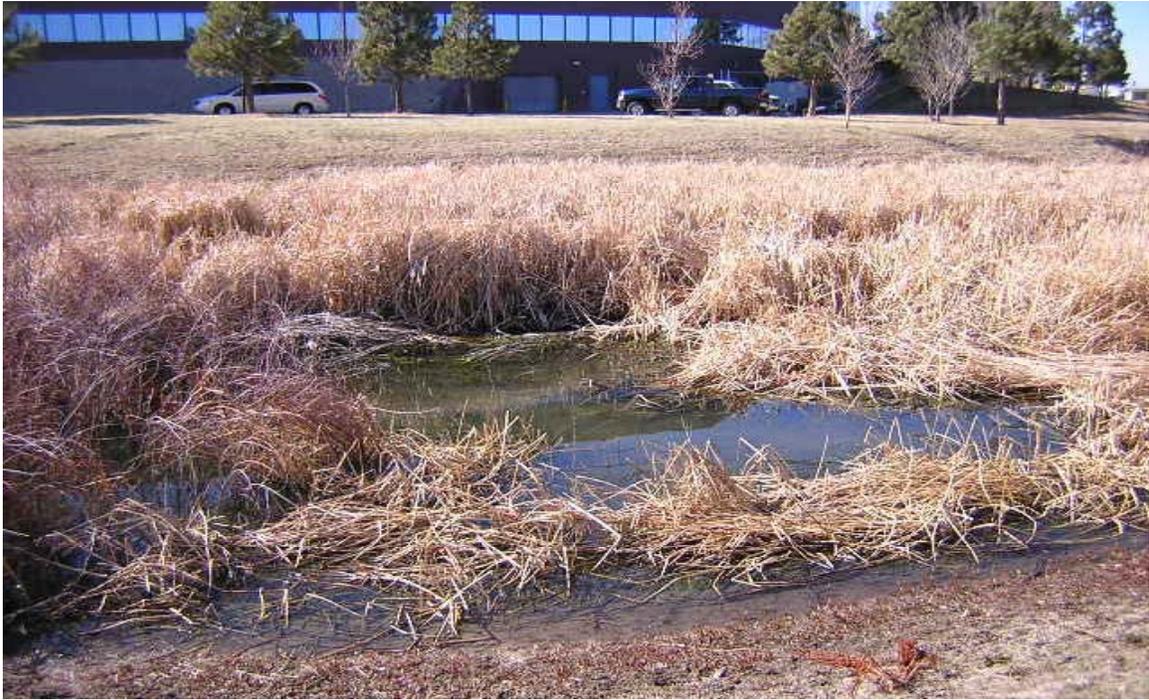
Site 1 was a large BMP, with substantial amounts of wetland type vegetation throughout the entire basin. Standing water was also noted throughout the basin. Concrete culverts at the north and south ends of the basin were surcharged with water nearly to the crown of the pipe. No outlet structure was apparent in the basin. Considering that there was no outlet structure and that significant wetland vegetation was present, it is possible that the facility could have originally been designed as a wetland BMP. The Arapahoe County inspector did mention that a concrete "trickle channel" was on the bottom of the basin.

The presence of the trickle channel would suggest that this BMP was not intended to be a constructed wetland BMP. The presence of standing water in the inlet or outlet culverts indicates that the pipes are completely surcharged with water, providing additional mosquito habitat. In addition, the inundation of the culverts and the trickle channel indicate that this BMP is holding significantly more water than the designers intended.

Figure 1: Wetland Vegetation and Standing Water

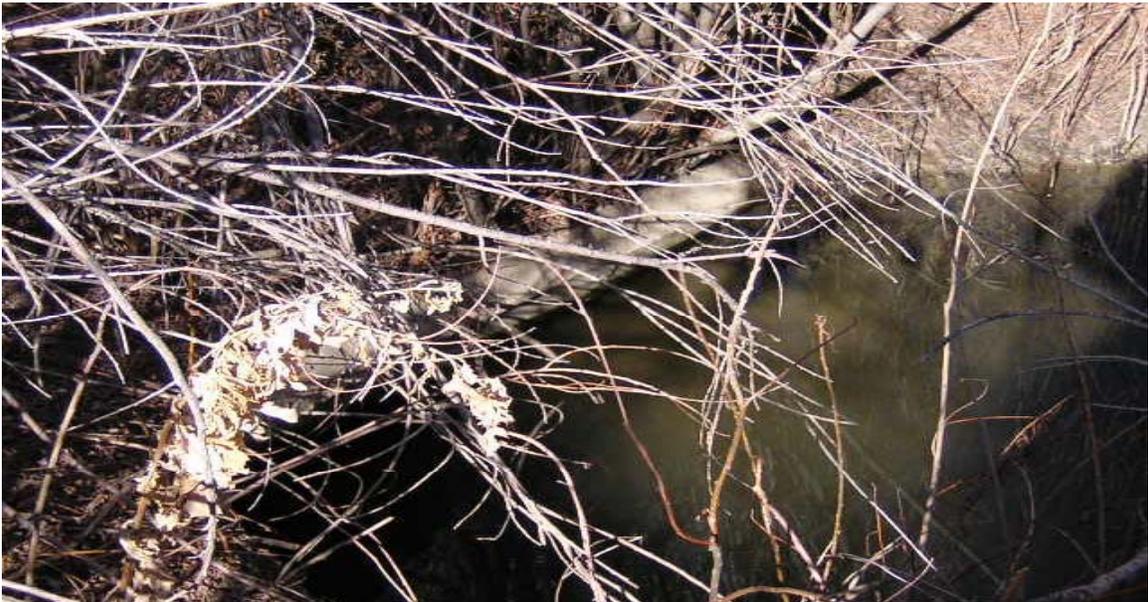
Figure 2: Concrete Culvert-Nearly Full of Water

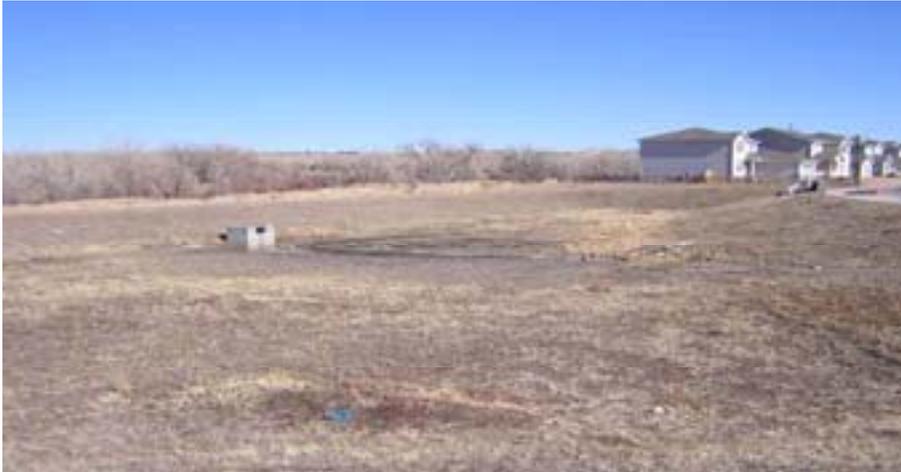
Site 2 was an extended detention basin (EDB) that was full of water during the 2003 mosquito season. As indicated in Figure 3 below, the EDB was dry when

the photo was taken on March 11, 2004. The photo shows a very short distance between the inlet culvert and the release structure. It is not clear whether this EDB was designed with a micropool, or if the micropool area had silted in. The lack of a clearly defined micropool with steep banks can contribute to mosquito production during periods of runoff. In addition, the rock around the outlet may have silted in, preventing the pond from draining between storm events.

Figure 3: Extended Detention Basin

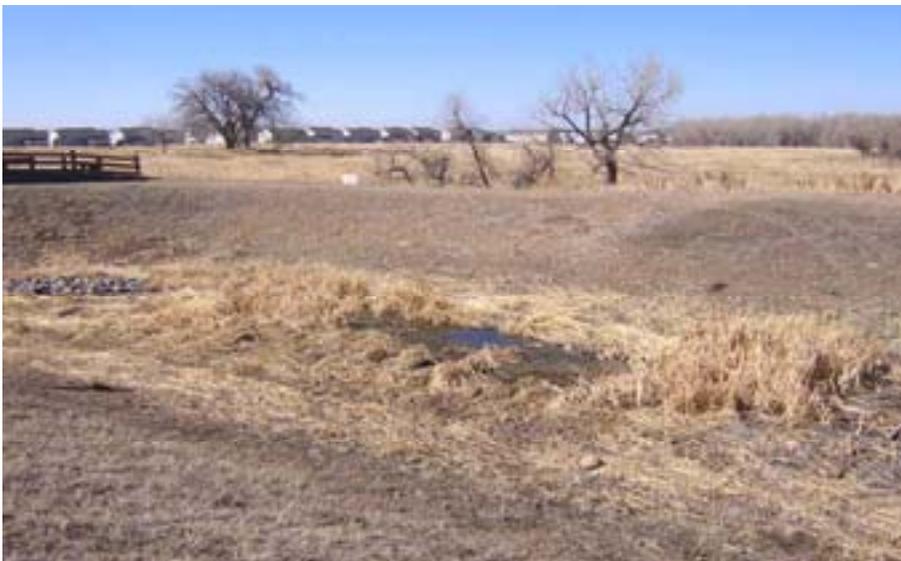
Site 3, in Figure 4 below, was another Extended Detention Basin. The inlet is shown on the left at the rip-rap. Standing water is noted near the inlet, and the continuous presence of water has created a lush vegetative growth conducive to mosquito production.

Figure 4: Extended Detention Basin, with “Permanent Water” and Wetland Vegetation

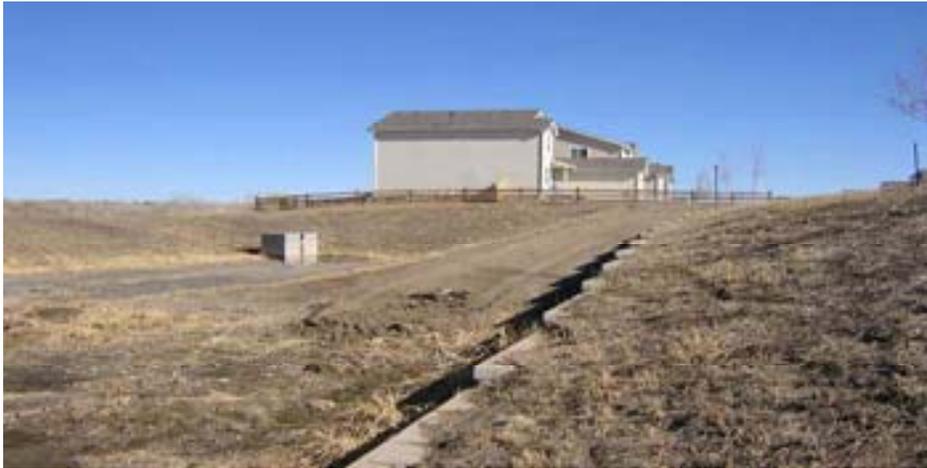
Site 4 was another EDB. As shown in Figure 5, the area where the “micropool” would be expected was possibly too “silted in” to allow the micropool to form.

This BMP was equipped with an access road to make it accessible to maintain by periodically removing silt accumulation near the outlet structure. This BMP also had rock around the outlet pipe, that may tend to clog with silt. The possible “silting in” of the micropool, combined with clogging that may result from the rock at the outlet results in shallow standing water from storm events that remains long enough to allow mosquitoes to breed.

Figure 5: EDB with Access Road and Rock Around Outlet Structure

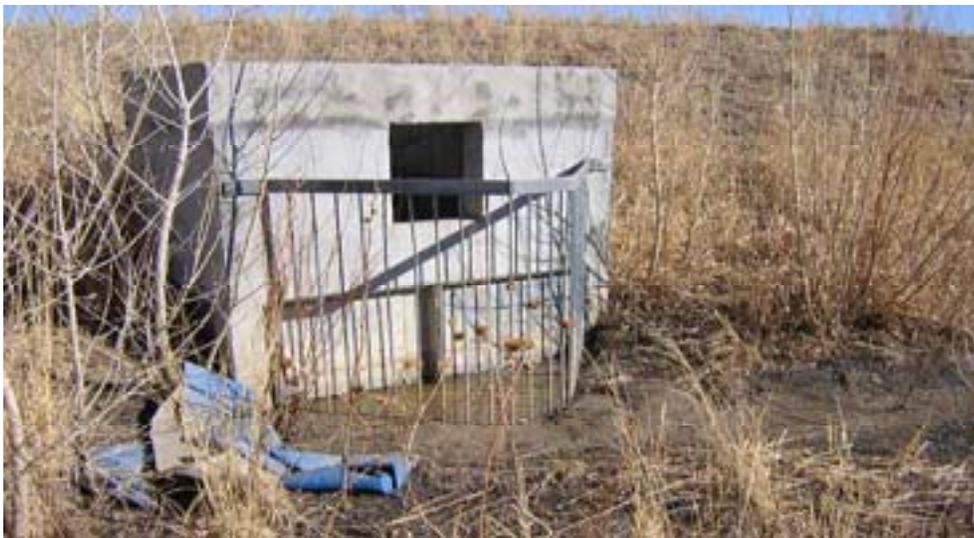
The outlet structure at Site 5 is shown in Figure 6 below. The photo illustrates significant clogging of the outlet structure that can lead to mosquito production. The micropool no longer exists as it was designed and shallow standing water remains long enough for mosquitoes to breed.

Figure 6: Outlet structure with heavy siltation, preventing drainage

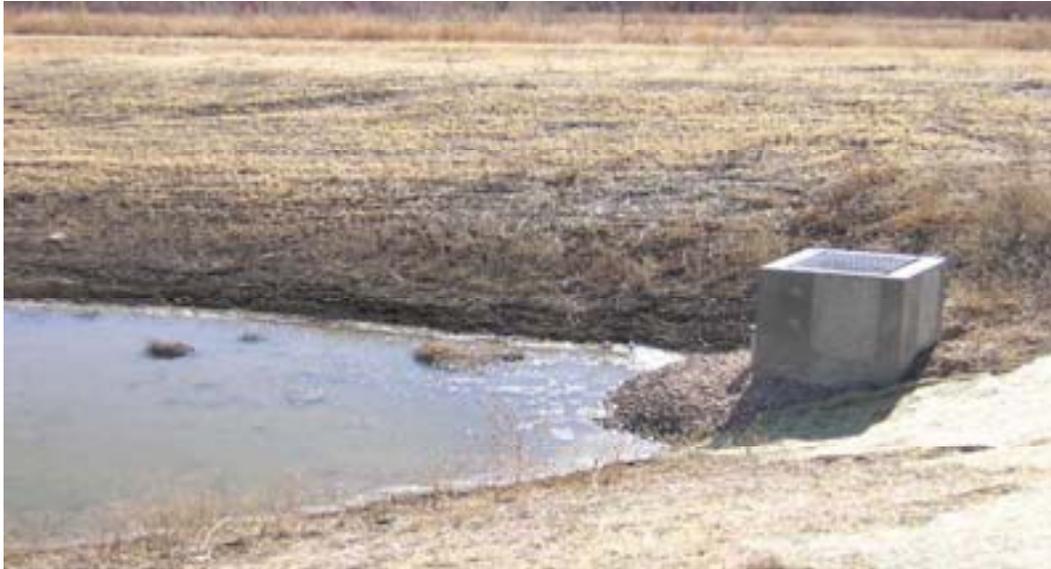
Site 6 is shown in Figure 7 below. This micropool. appears sufficiently shallow and has sufficient stagnant water with organic matter to produce mosquitoes. The rock at the outlet is prone to clogging.

Figure 7: EDB with Micropool & Rock Outlet

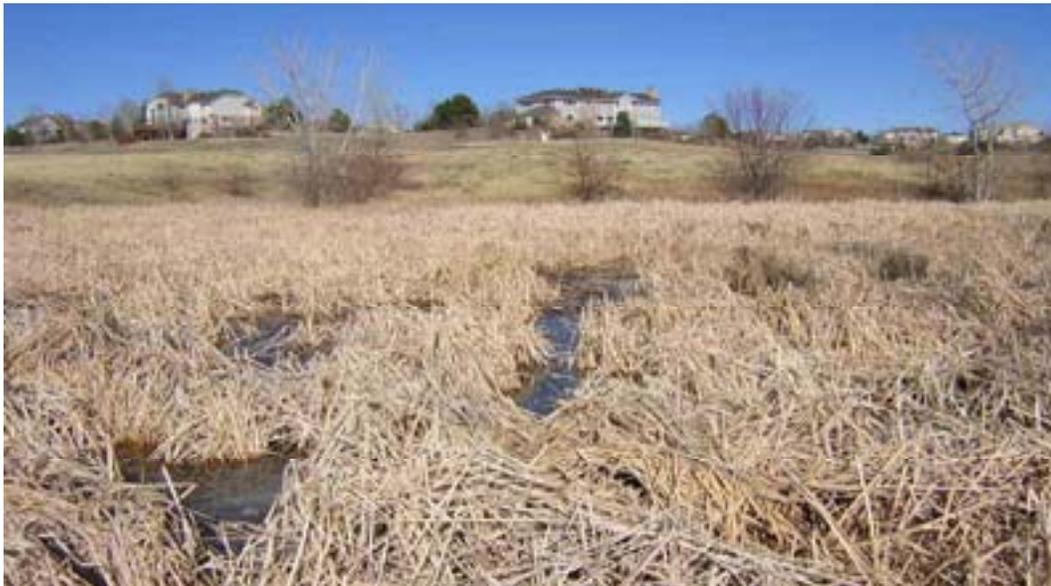
Figures 8 and 9 below are from Site 7. Figure 8 indicates two primary conditions for mosquito breeding: 1) permanent, stagnant, standing water; and 2) heavy vegetation that produces organic matter.

Figure 8: EDB? With Permanent Standing Water and Wetland Vegetation

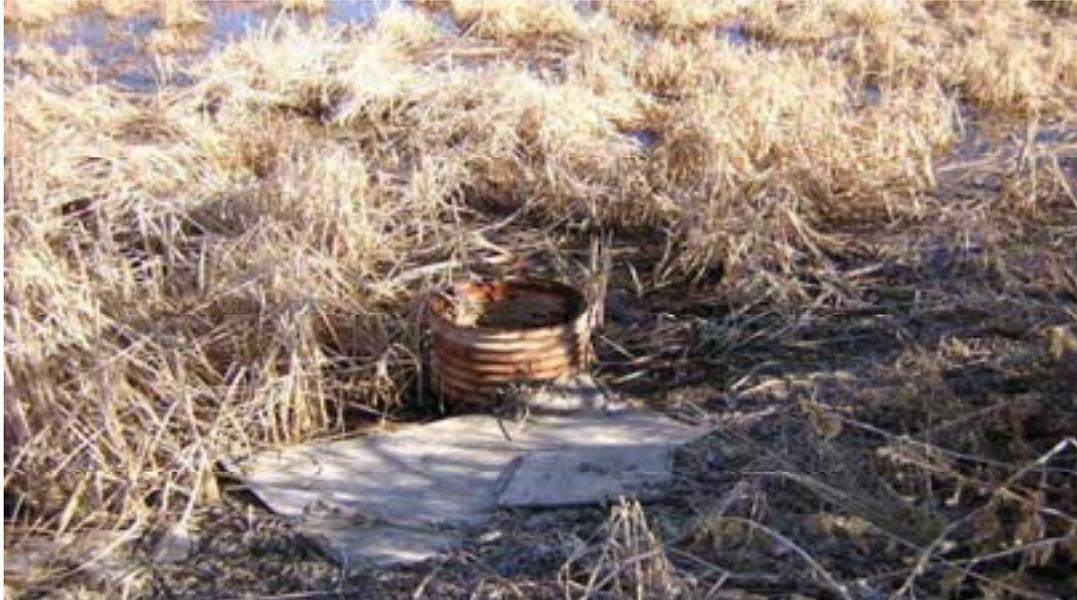
Figure 9 shows an outlet structure at Site 7. It is apparent that the outlet structure does not release sufficient water to have prevented this BMP from

becoming a large wetland. This site has produced large numbers of mosquitoes for many years.

Figure 9: Outlet Structure of Perforated CMP Culvert

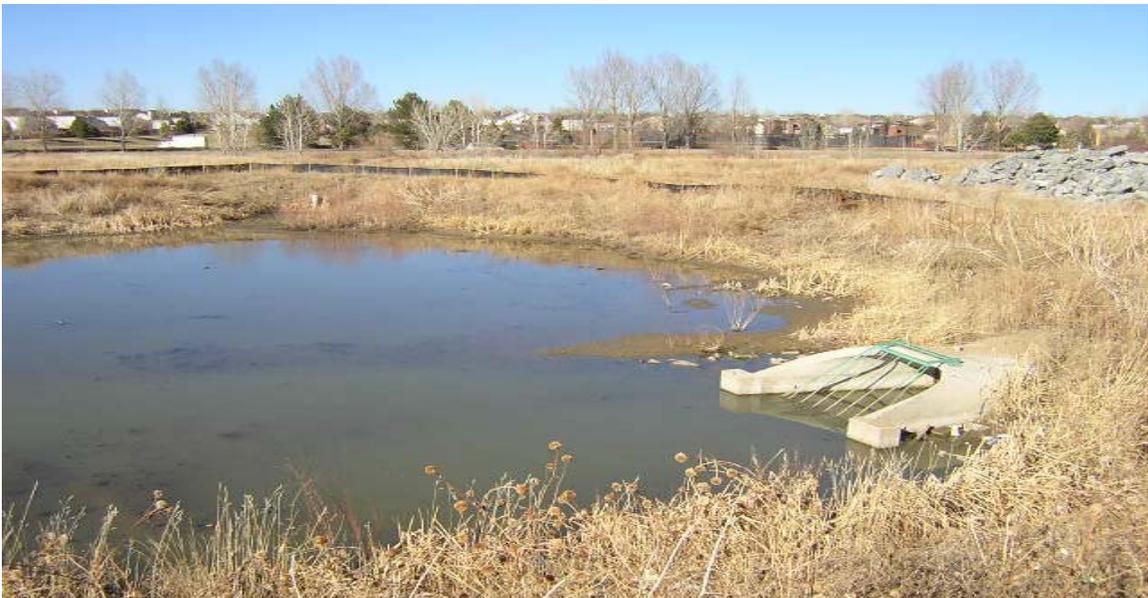
Figure 10 below is from Site 8. It is unclear whether the standing water shown in Figure 10 was intended to be a micropool or a forebay. The inundation of the culvert does not appear to be intended. Although this BMP was implicated in the production of mosquitoes in 2003, it does appear that it has the potential to produce mosquitoes.

Figure 10: EDB-Not a mosquito site in 2003, but has potential!
